# **The need to get the salt out:**

## Dealing with rising damp and salt attack

David Young OAM BAppSc  
Heritage Consultant  
PO Box 203, Clifton Hill VIC 3068  
[david.young@netspeed.com.au](mailto:david.young@netspeed.com.au)

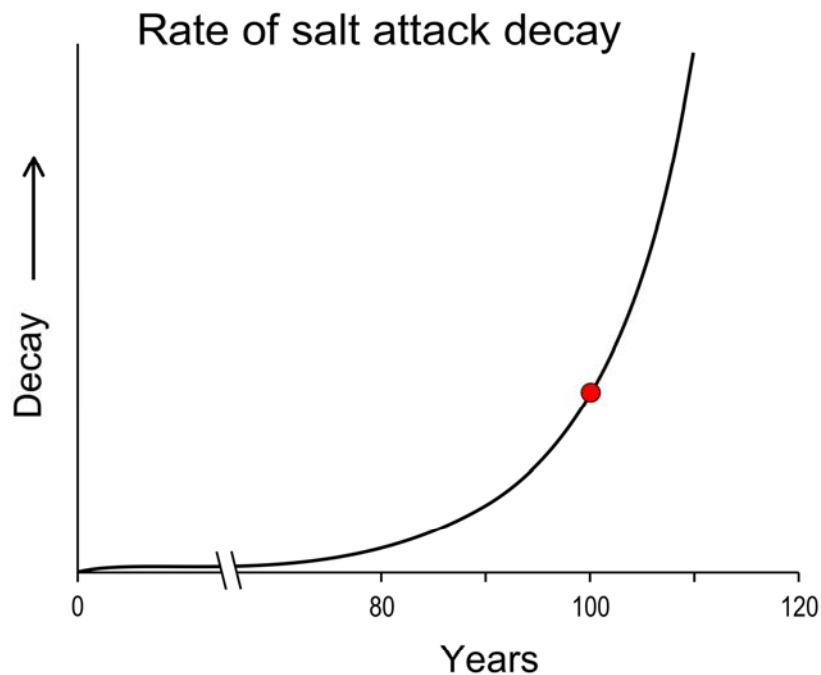
Rate of salt attack decay. While this a notional example, it illustrates how it would be wrong to think that because decay has taken 100 years to get to the present state (as shown by the dot on the graph), there is no urgency about taking remedial action. In this case decay would be nearly three times worse in only ten more years.

Consider the example of a 100 year old house. It is well built, with brick walls and lime mortar, and sits up on a well drained block with no ponding of surface water against the house. Yet the lime mortar of the lower 5-10 courses of brickwork is eroding and in places the loss is up to 50 mm from the wall face. The bricks are in reasonable condition, showing only the first signs of deterioration. There is no damp-proof course and not a lot of dampness in the walls. On the inside the plasterwork is in good condition with only a few areas of blistering beneath paint coatings. It is tempting to think that as the house has lasted 100 years, the decay will not be much worse after another 20 or 30 years. Postponing action on this basis would be wrong, as the following graph shows.

This sacrificial mortar will last for a variable period depending on how much salt remains in the walls (in the remaining mortar and in the adjacent bricks) and on how well the repointing has been carried out. If there is substantial salt remaining in the bricks this will migrate into the new mortar and cause it to decay in not many years. A second round of repointing may be necessary after 5-10 years, but this should substantially reduce the salt burden in the walls. In doing so, it effectively resets the position on the graph above back to a point where there's little decay.
